*Worldwide repairs carried out with PolymerMetal®*

**REP-# 068**

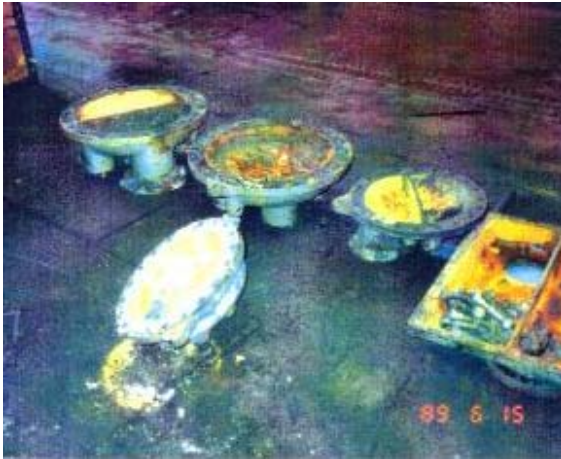
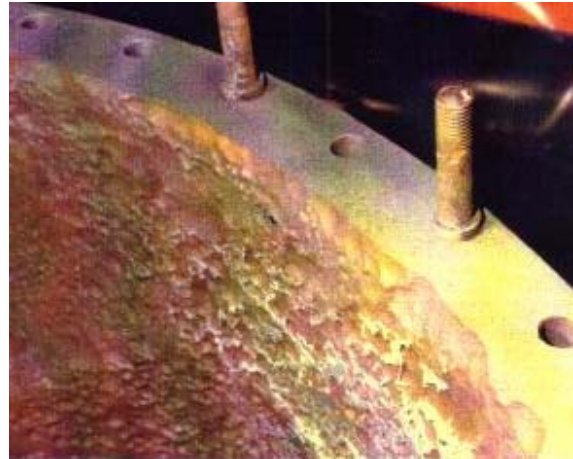
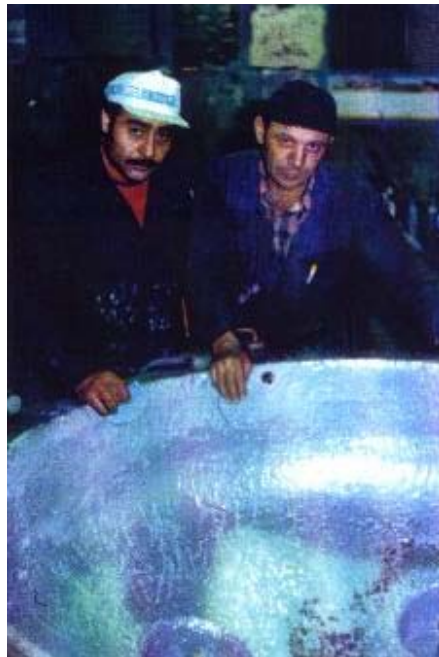
Because of bad maintenance during the resting period the covers of 3 auxiliary capacitors, each 6 m<sup>2</sup> were affected by erosion of up to 3 cm depth. The volume for filling was obtained by applying 200 kg Ceramium and Hardener CE.
