Worldwide repairs carried out with PolymerMetall®

REP-# 097

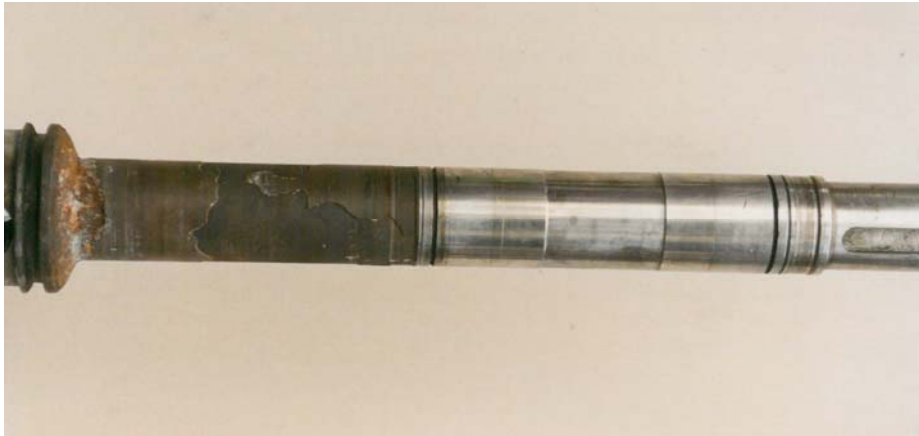
Due to corrosion creep the coating peeled off at a bigger area in the zone of the stuffing box packing of a shaft treated with flame spaying (1. picture). After suitable surface preparation the shaft was coated with the wear resistant material Ceramium, pasty (2. picture), after curing machined to nominal measure (3. picture) and finally put into operation again in a paint coating machine at a paper mill. The formerly common company repair solution by metal spraying was not considered because the machine would have been too long out of order.
