*Worldwide repairs carried out with PolymerMetall®*

**REP-# 115**

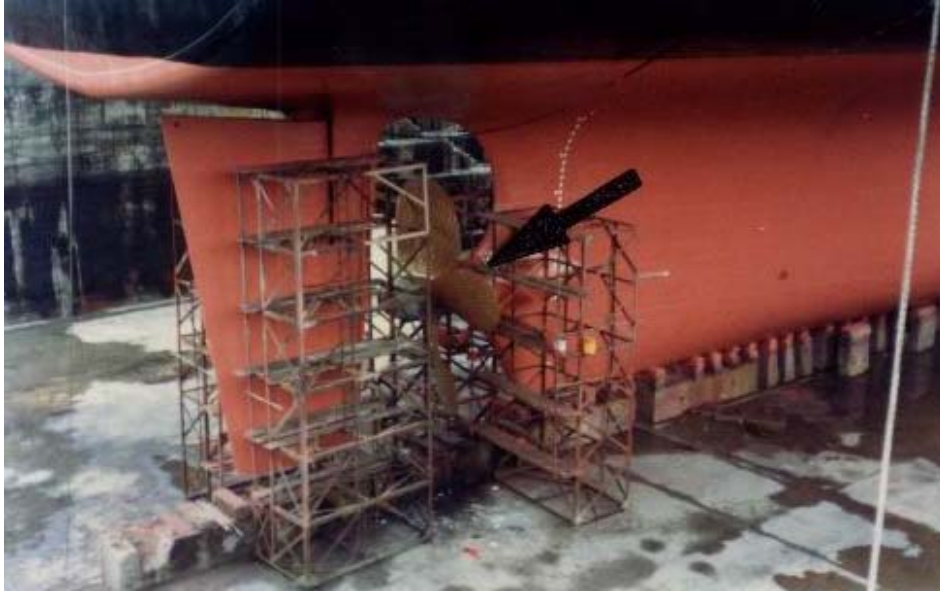
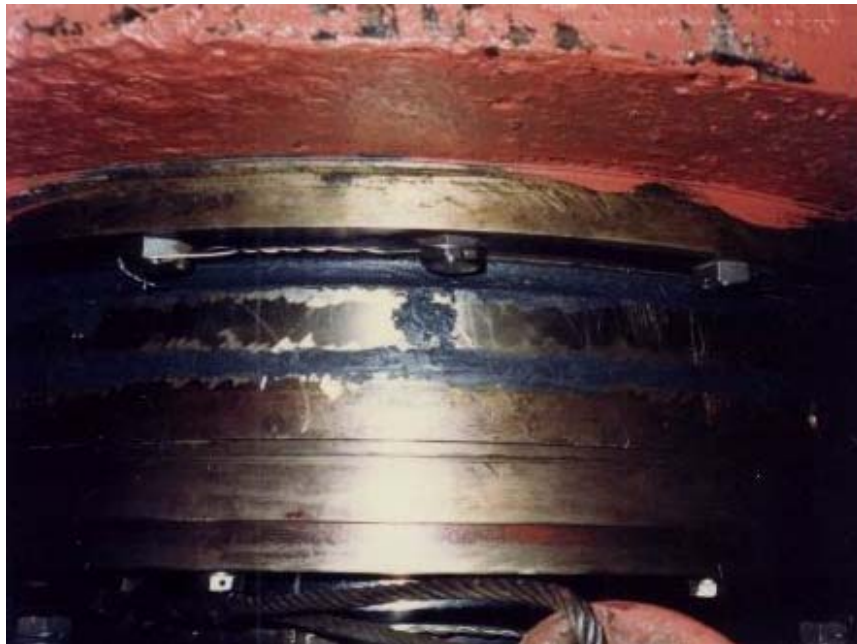
Repair of a leaking simplex compact packing. The repair was difficult due to oil pouring out of the repair site. Therefore it was decided to use the direct-MM-bonding method by applying the PolymerMetall directly on the greasy surface. Here MM-metal oL-steelceramic with Hardener red was chosen.
